Volume: IX
Number: TC00-028
Date: 09/25/2000
☒ Action
☒ Retain
☐ Information

SUBJECT: SPECIAL SERVICE CAMPAIGN - Y04
(2000 MODEL YEAR ECHO BRAKE VACUUM PORT - COLD STATES ONLY)

TECHNICAL INSTRUCTIONS
FOR
SPECIAL SERVICE CAMPAIGN Y04
2000 ECHO
AIR TUBE
(19 Cold States Only)

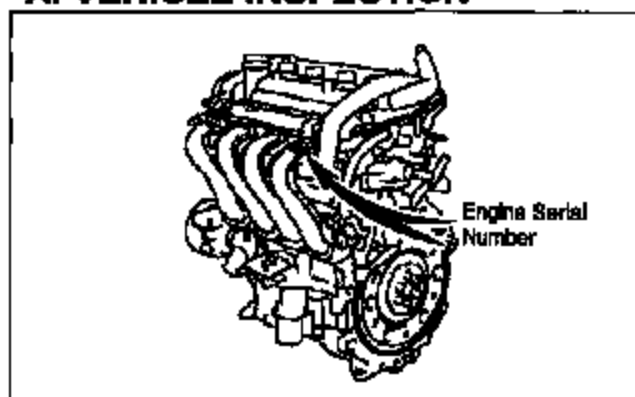
1. INSPECT ENGINE SERIAL NUMBER.

- Check that the engine serial number is within the range listed below.
- The engine serial number is located on the cylinder head, between the intake runners for cylinders 3 and 4.
- If engine is not within the range below proceed to **Step VI**.
